Başarı Hikayesi

Endüstri: Yiyecek ve İçecek

Uygulama: Oven Fan Unit

Toplam Maliyet Tasarrufu: € 34 907

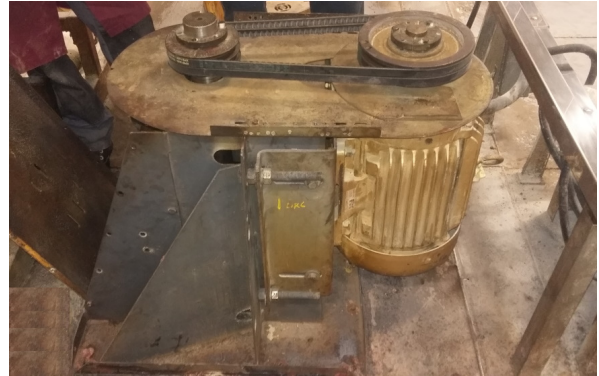
A leading UK Bakery was experiencing regular, unexpected production stoppages, due to premature failure of pillow block ball bearing mounted units, fitted to a high temperature oven re-circulation fan unit. This resulted in significant disruption to production, high downtime costs and spoilt product. NSK conducted a full evaluation of the application incl. failed bearing analysis and concluded that the bearings were seizing from excessive pre-loading and incorrect lubrication selection on installation. NSK proposed Plummer Blocks with high capacity Spherical Roller Bearings and Labyrinth seals, and recommended the correct bearing location and lubrication. This solution resulted in an immediate improvement and significant service life extension by a factor of 4.5 times.

↑ Oven Re-Circulation Fan Unit

- Following repeated and costly bearing failures the customer requested a solution to their problem on an over re-circulation fan unit.
- NSK Application Review determined the bearings had failed from excessive pre-loading and inadequate lubrication.
- NSK proposed SNN Plummer Blocks with HPS Spherical Roller Bearings and Labyrinth seals, with recommendations on correct bearing location and lubrication.
- A trial was conducted using the NSK recommendations with a 4.5 times life extension.
- This resulted in a reduction of machine downtime and maintenance costs and a significant annual cost saving
